**Issue 3/2002**

## High Density Altitude Suspect in Loss of Control

On July 1, 2000, the owner of an Aeronca 65-CA took off from his private aerodrome near Fort Steele, British Columbia, at about 20:00 MDT for a local flight. The pilot was accompanied by his teenage nephew. The aeroplane was observed to remain close to the ground after it lifted off from the grass strip. As it approached a stand of trees at the end of the strip, it turned, probably to avoid the trees. The bank angle appeared steep, and the aircraft pitched nose down, descended rapidly, and struck a house. The pilot and the passenger were seriously injured. The residents of the house were in the backyard and escaped injury. The aircraft was substantially damaged. This synopsis is based on Transportation Safety Board of Canada Final Report A00P0115.

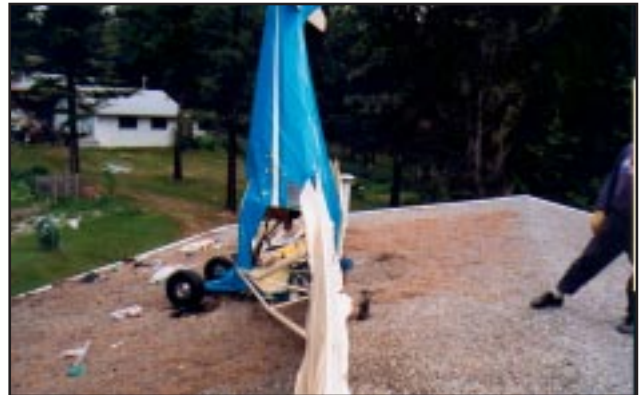
*The direct hit on the roof likely saved both occupants, as it cushioned the impact.*

The occurrence takeoff was to the north. The aeroplane appeared not to be climbing very well. It reached about 50 ft, and as it approached a stand of trees at the north end of the field, it appeared as though the pilot was manoeuvring the aeroplane around the high trees. During the manoeuvre, the aeroplane's bank angle seemed to steepen, and the nose dropped. The aeroplane then descended steeply and struck the roof of a house. The nose, engine, and front cockpit of the aeroplane penetrated the house. The fuel tank ruptured, fuel spilled into the house, but did not ignite.

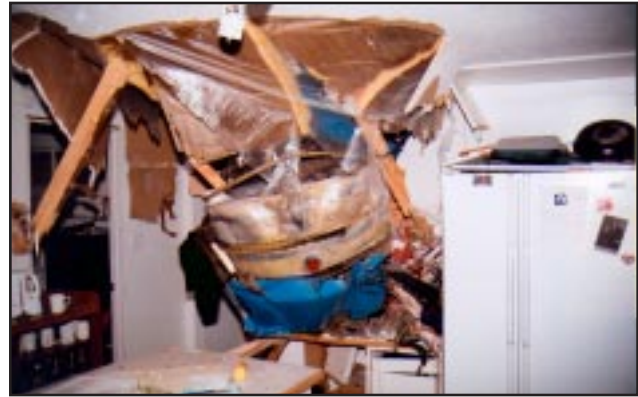
Interior damage shows again how [relatively] lucky the two occupants were.

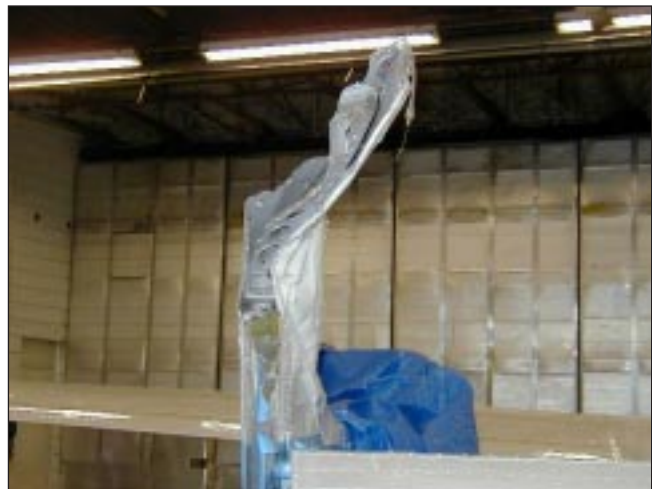
The Cessna 172 was descending on a steady southwesterly heading when the two aircraft collided. The nose gear of the Cessna 172 struck the left vertical stabilizer of the Cessna 337. Approximately half of the left vertical stabilizer and left rudder separated from the Cessna 337. The Cessna 172 nose gear assembly was damaged. Both pilots were able to maintain control of their aircraft. The Cessna 172 instructor pilot continued to Toronto/City Centre Airport and landed safely. The Cessna 337 pilot returned to Toronto/Buttontville Municipal Airport and landed without further incident. The accident occurred during daylight hours, in visual meteorological conditions (VMC).

Close-up view of the Cessna 337 damaged left vertical stabilizer.

Transport Canada initiated a System Safety Review of VFR operations in the Greater Toronto Area following the occurrence. This is a systematic evaluation process in which a Safety Review Team identifies hazards and system deficiencies and develops mitigation plans for these hazards and system deficiencies. The operator of the Cessna 337 has taken steps to improve the safety of the operation. The aircraft is operated with landing lights, navigation lights, anti-collision lights and beacon activated.

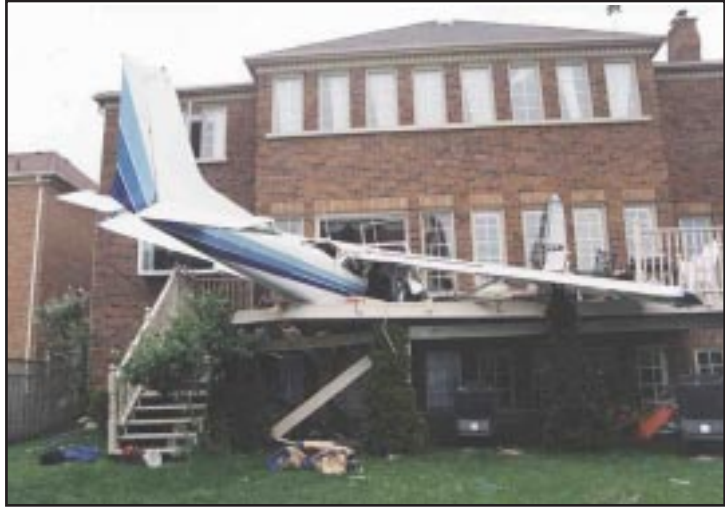
The aircraft was later examined and the fuel selector was in the OFF position. All other controls and switches (mixture, magnetos, and master switch) were in the engine operating position and had not been moved. Damage to the fuel selector mechanism indicated that the fuel selector was OFF at impact. The propeller bent rearward when it struck the deck; there was no indication of propeller rotation. The aircraft departed with ample fuel for the intended flight, and there were no indications of contaminated fuel. An inspection of the engine revealed no mechanical abnormalities that could explain the engine stoppage.

explained by any observed engine defect. Considering the phase of flight and the sudden stoppage of the aircraft engine with no prior indications of power degradation, carburetor icing was unlikely a factor in the power loss. The engine magnetos were tested and found to be functional, thereby eliminating the ignition source as a factor in the engine stoppage.

The TSB could not determine why the engine stopped during the initial climb. After the engine stopped, directional control of the aircraft was not maintained, and the aircraft turned left and crashed into a residential area. This occurred when the pilot removed his hand from the control column during his attempts to restart the engine. Because of the low altitude at which the engine stopped, the pilot believed that he did not have sufficient time to conduct the appropriate emergency checklist. He concentrated his efforts on restarting the engine to the detriment of maintaining aircraft control, completing the appropriate checklist items, and conducting an effective forced approach and landing.

*Lesson learned*—While the cause of the engine stoppage was not determined, the main lesson we can draw out of this is the importance of following the correct procedure for an engine failure after take-off, in sequence, as time and altitude permit. If the engine fails immediately after take-off, you may only have time to close the throttle, attain a recommended landing path, and concentrate on a good landing. Do not become so engrossed in doing checks that you jeopardize the chances of making a good approach and landing. A qualified flight instructor will be glad to review this topic with you at any time. △
